East Woodland

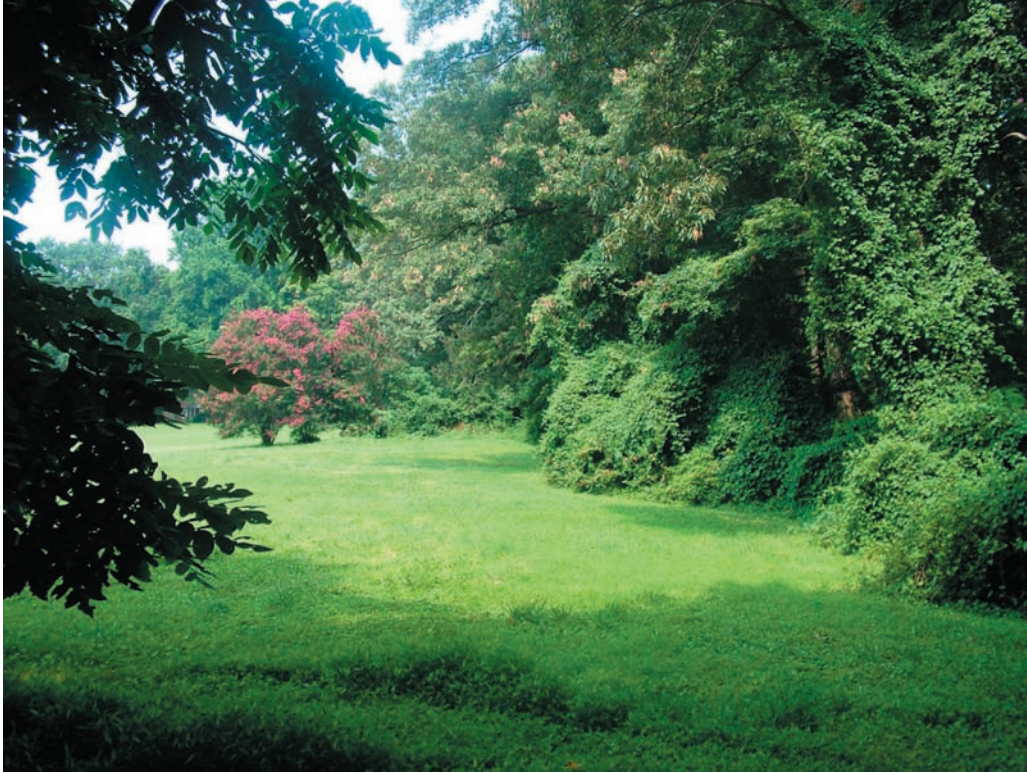
Figure 4-4: View along northern edge of the east woodland.
789

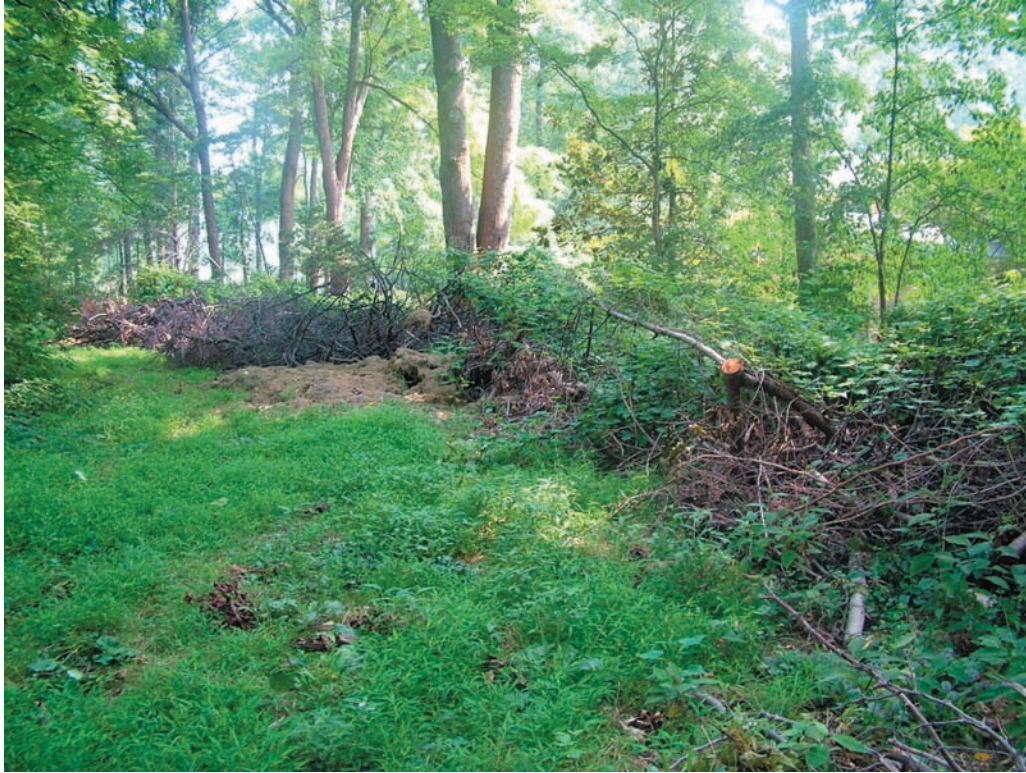
Figure 4-6: View of debris piles along eastern property line.
783

investigation of trees near structures and the woodland edge should be conducted to identify those trees in poor condition that would cause damage if they were to fall. Hazardous branches should be selectively pruned and debris removed. Tree removal should be considered within the context of this property's overall management plan as dead trees and branches provide wildlife habitat and are relatively rare in a predominantly suburban landscape. Leaving dead trees and branches to decompose naturally within the woodland area, or grinding and returning plant material to the site, should also be considered as long as these practices do not detract from the aesthetic qualities of the gardens.

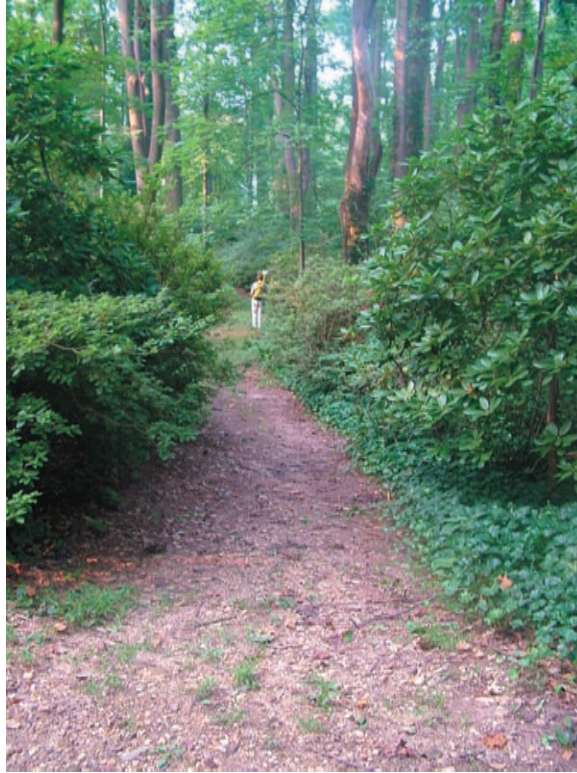
The overall condition of this area can be considered **fair** due to the abundance of exotic invasive species. The condition could easily become poor if the invasive plants are not properly managed. Overall, plants are in good condition as most trees observed appear to be free of wounds, pest infestation, and disease; overall vigor is high; and plant growth and form appears normal. However, the present infestation of exotic invasive plants warrants a fair condition assessment in order to address expected decline of plant vigor and to emphasize the level of management needed to address the situation.

Figure 4-7: View of west woodland from woodland trail. 752

- The removal of invasive plants would improve overall native species composition and diversity of this stand. The intense concentration of English ivy, privet, and bush honeysuckle within this area poses the largest management issue. See Treatment Recommendations for Invasive Plant Species at the end of this chapter.

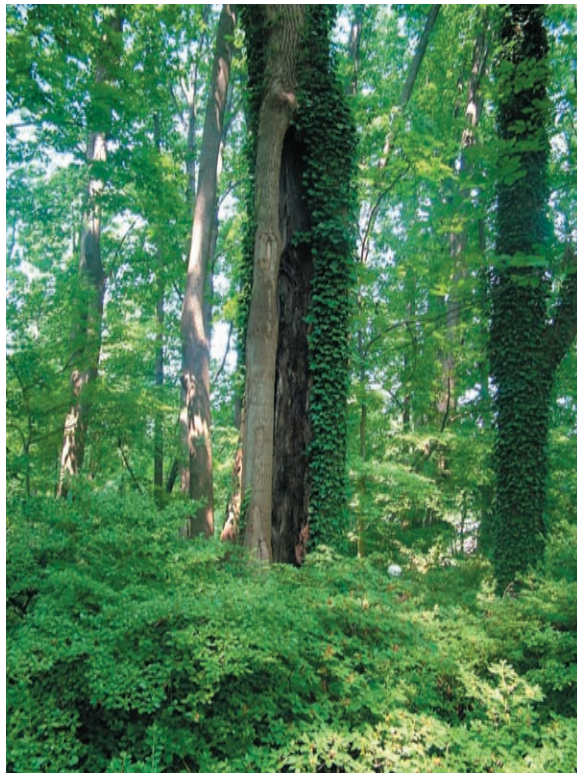
Figure 4-8: English ivy growing on tree trunks. 718

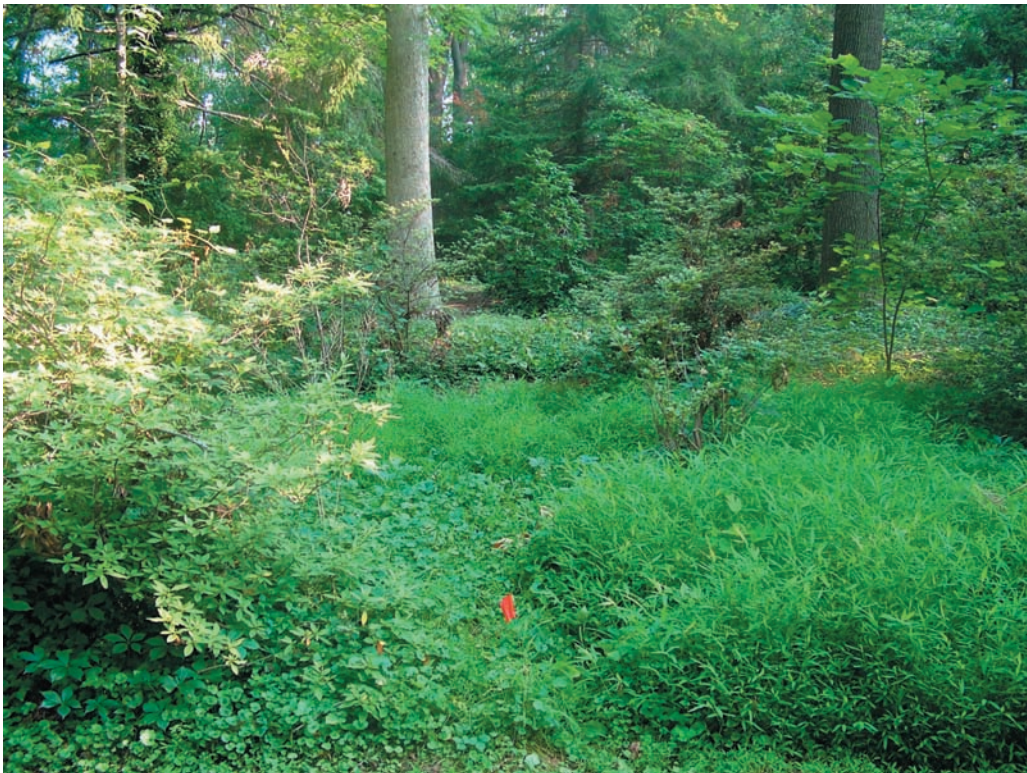
Figure 4-12: Large concentration of microstegium in garden bed.
675

- As with the upper garden, invasive groundcovers like English ivy and microstegium pose a potential threat to the surrounding woodlands. Microstegium should be removed as it was not planted but rather spread in from outside sources. English ivy was most likely planted, and if it is eventually determined desirable in the garden beds, it should be actively contained by routine maintenance. The other ornamental groundcovers in this area pose only a minor threat of woodland invasion, but should be regularly observed and maintained nonetheless. See Treatment Recommendations for Invasive Plant Species at the end of this chapter for more information.

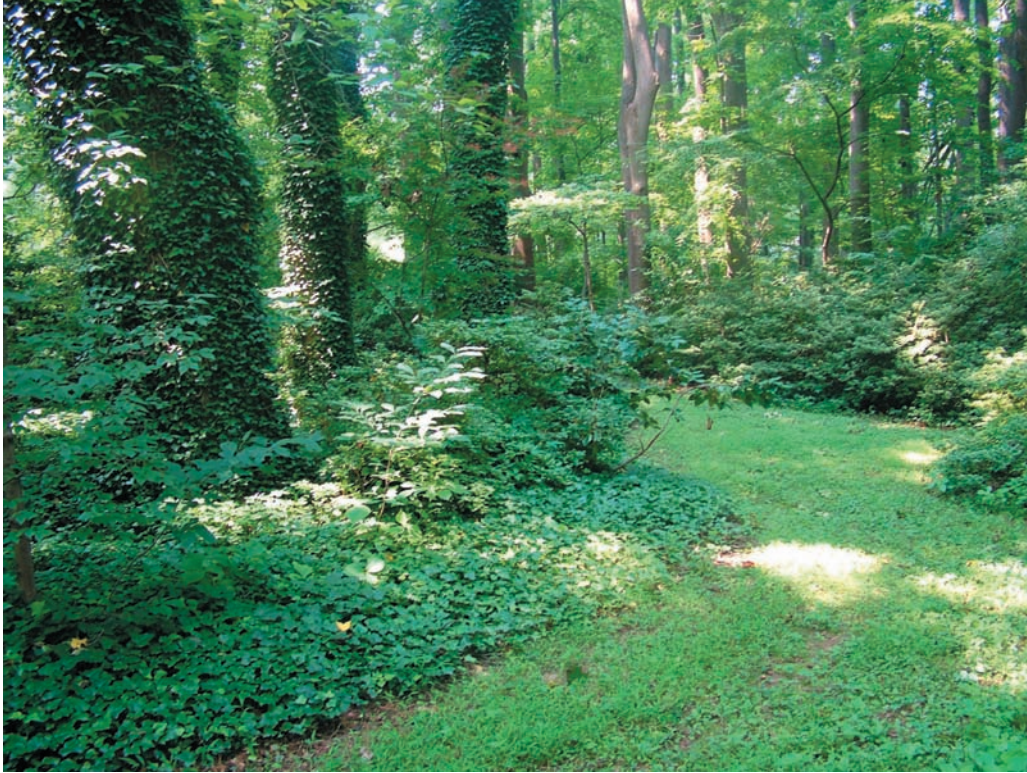
conditions decline towards the south. In the southern portion of the character area, azaleas in sunny areas are turning yellow and show signs of stress. There are numerous invasive plants throughout this area that will continue to spread into the western woodland area. Several beds contain bush honeysuckle and privet. Large concentrations of microstegium in many of the beds are out-competing the cultivated herbaceous plants. English ivy poses another threat, particularly in one bed where every tree trunk is covered. Other vines like wisteria, smilax, and grapevine may eventually shade out or stunt the growth of shrubs if they are allowed to continue growing on them. Most of the trees in this area are in good condition but those infested with ivy will decline if the ivy is left unchecked. The nursery is another area of concern as it is significantly overgrown.

Figure 4-13: Garden bed exhibiting large concentration of English ivy infestation.
713

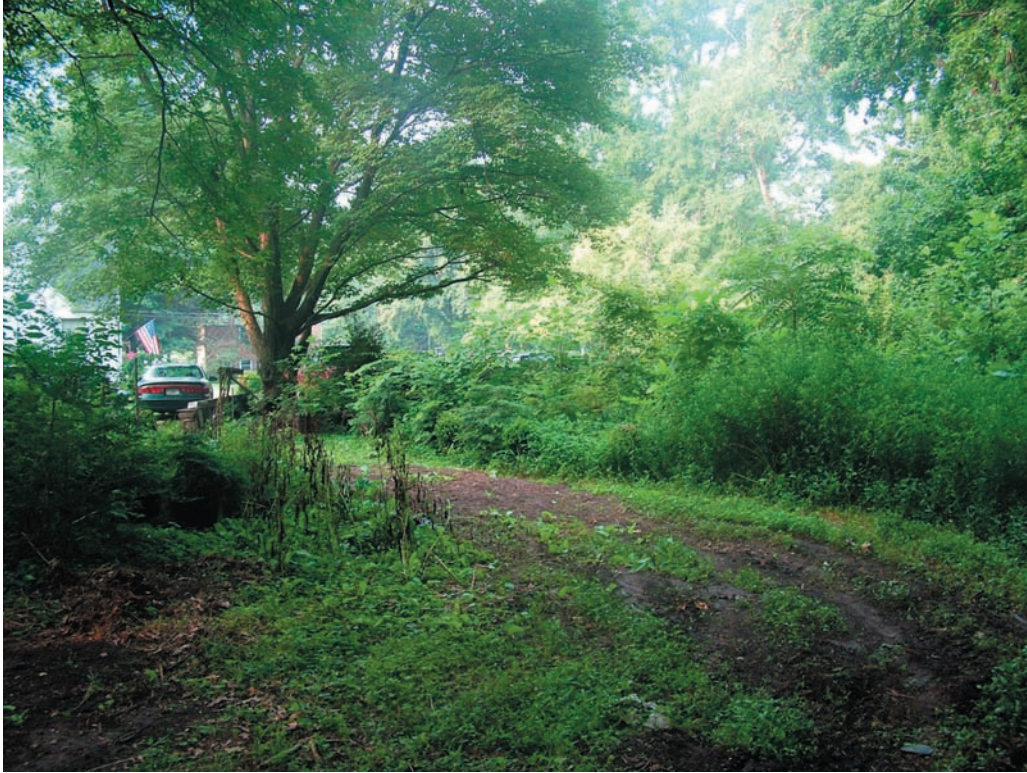
Figure 4-15: Overgrown nursery area.
759

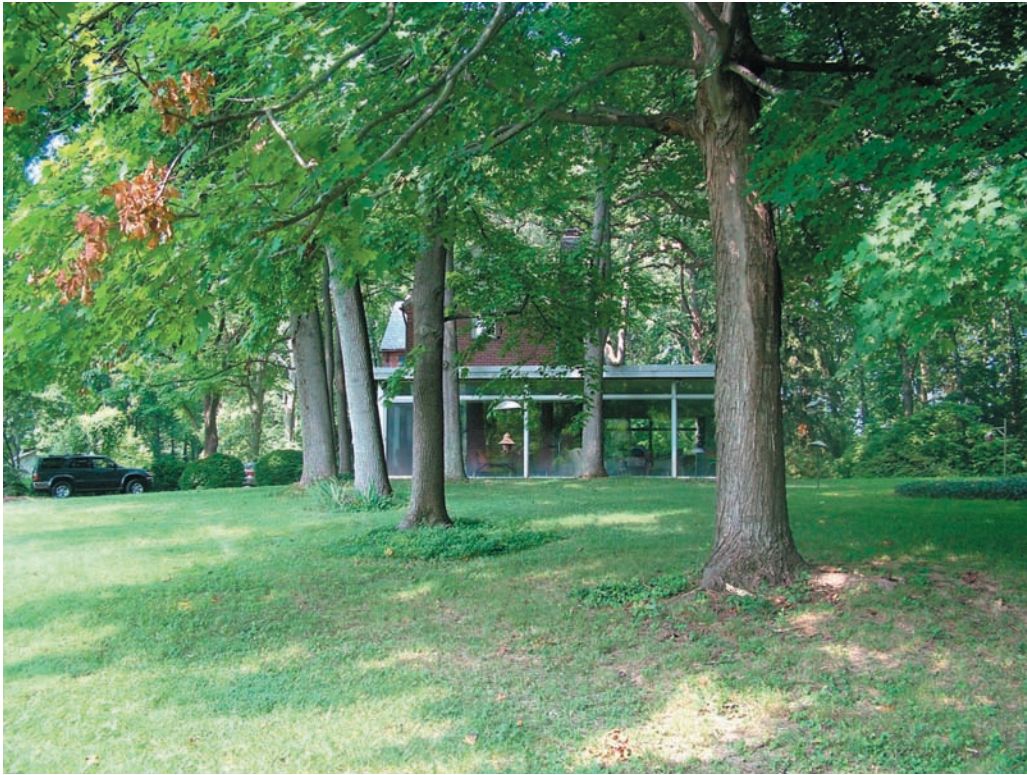
Figure 4-17: Mixture of hardwood trees around glass porch.
641
